**AIRCRAFT ACCIDENT REPORT. UNITED AIR
LINES, INC. B-727, N7036U, IN LAKE
MICHIGAN**

**NATIONAL TRANSPORTATION SAFETY BOARD,
WASHINGTON, D.C**

16 AUG 1965

UNITED AIR LINES, INC.
BOEING 727-22, N7036U, in LAKE MICHIGAN
AUGUST 16, 1965

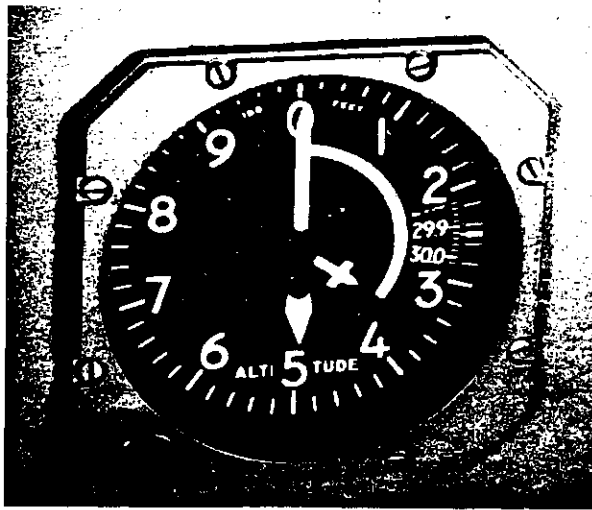
Baro. 29.92

Alt. 35,000

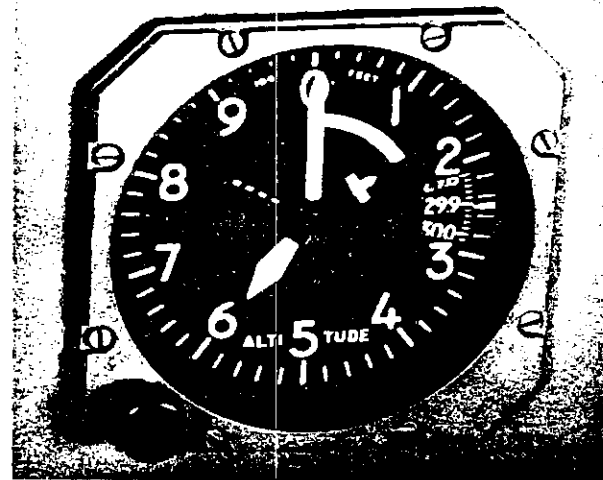
A review of Attachment No. 2 shows the position of the hands of the altimeter could be misinterpreted under certain operating conditions and the crew could have misread 6,000 feet to be 16,000 feet. It is believed the first officer was flying the aircraft. The captain's voice was identified on the air traffic control tapes and it is a normal custom in air carrier operations to have the pilot who is not flying the aircraft make the radio transmissions. If the captain were looking outside the aircraft for traffic or occupied with cockpit duties such as the completion of a checklist, and the first officer misread the altimeter, this error could escape undetected. To have such an error occur, however, it would be necessary for the pilot or pilots to fail to see the gradually increasing display of the cross-hatched warning section of the altimeter and the gradually decreasing display of the

Baro. 29.915

Alt. 16,000

Camera lens: 34" from dial 22° above and
15° to left of altimeter axis

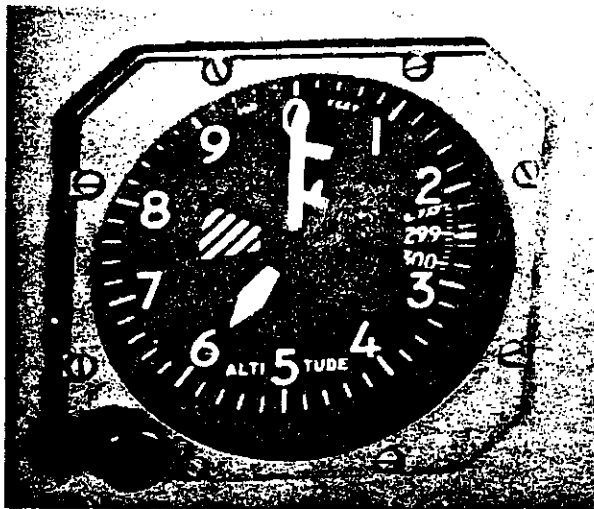
Baro. 29.915

Alt. 6,000

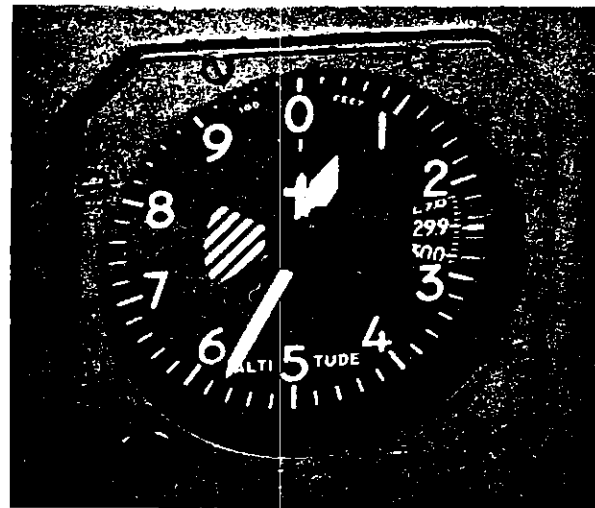
Baro. 29.915
